Technical Support Bulletin 2023-01	IFCB Adjustment to Sheath Pump Drive Magnet Placement	January 20, 2023
---	--	-------------------------

Instruments: IFCB

Subject: Adjustment to Sheath Pump Drive Magnet Placement

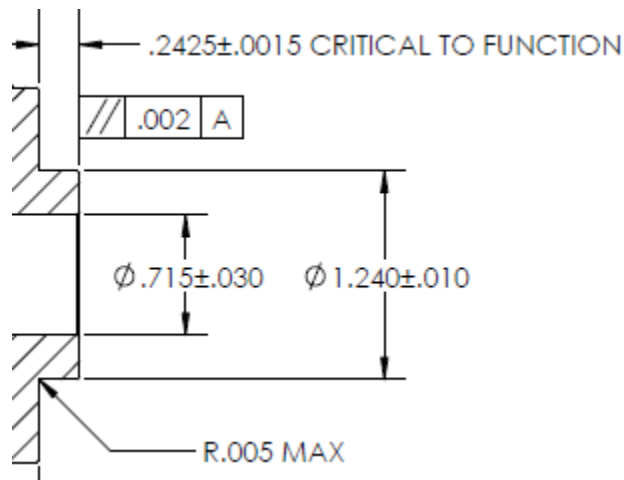
Technical Details: The height at which the sheath pump drive magnet is set relative to the base of the magnet cup is critical to stable / long-term operation of the pump heads. If this height is set out of specification, internal components of the pump head can interfere and ultimately become damaged. The damage that can occur will eventually be detrimental to pump operations and may cause complete failure of the pump to move fluid. The dimension measured from the bottom of the magnet cup to the bottom of the magnet is required to be 0.2425” +/- 0.0015”. To allow for this clearance height, McLane needed to redesign the motor mount plate to allow for recessed screw heads. McLane has also manufactured a fixture to allow for consistent placement of the drive magnet onto the motor drive shaft.

Current IFCB users with an IFCB prior to IFCB 187 should make this repair a priority at your next convenience.
To coordinate this repair, please contact:
