Technical Support Bulletin 2014-04	MMP or ITP Inductive Transmission Timeout	September 3, 2014
---	--	--------------------------

Subject: IMM Timeout

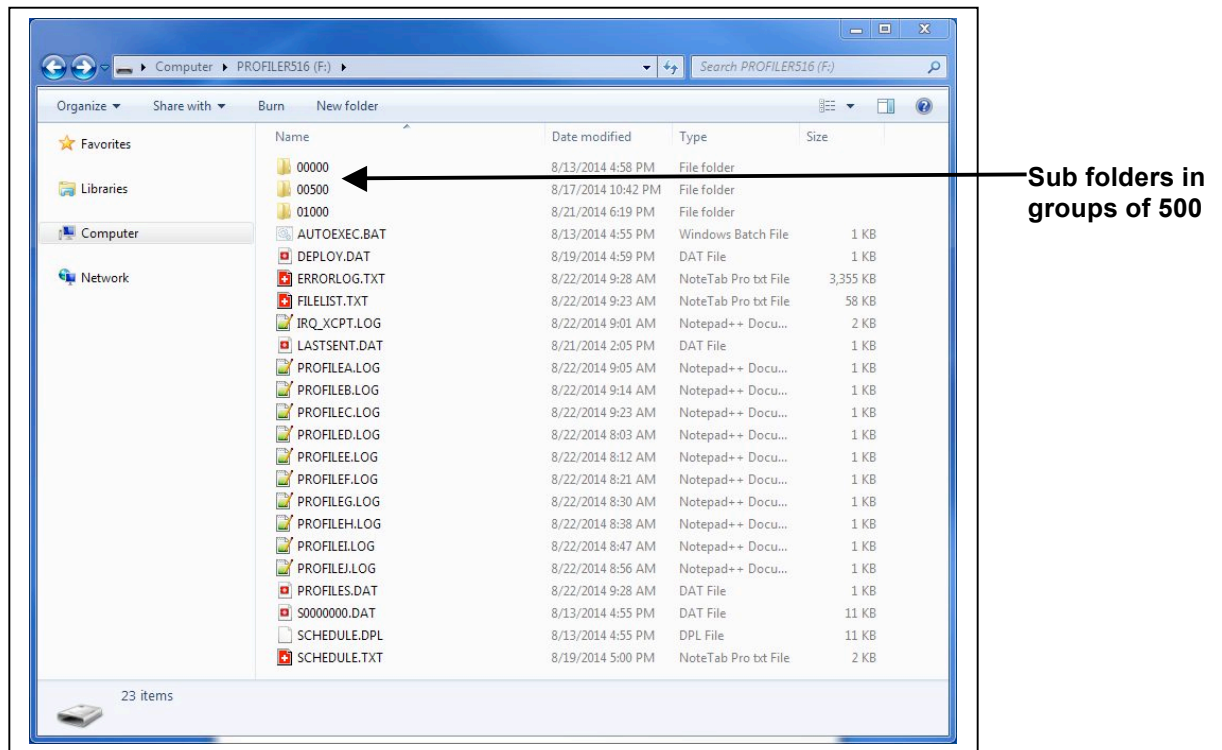
Figure 1: New Sub-Directory Structure on CF

Actions: Contact McLane to get Profiler firmware v5.16 and perform the upgrade on your system. Profiler v5.16 and higher have a new CF card directory structure (Figure 1). With the new structure, the firmware can locate and send data files to the surface controller within the 30 seconds required by the Sea-Bird IMM. For more information about the new directory structure refer to the Profiler v5.16 Release Note.
